Periodic Dam Safety Inspection Report

Beitey Lake Dam
Stevens County, Washington

June 2001
Pub. No. 01-11-009

Water Resources Program
Report 01-11-009

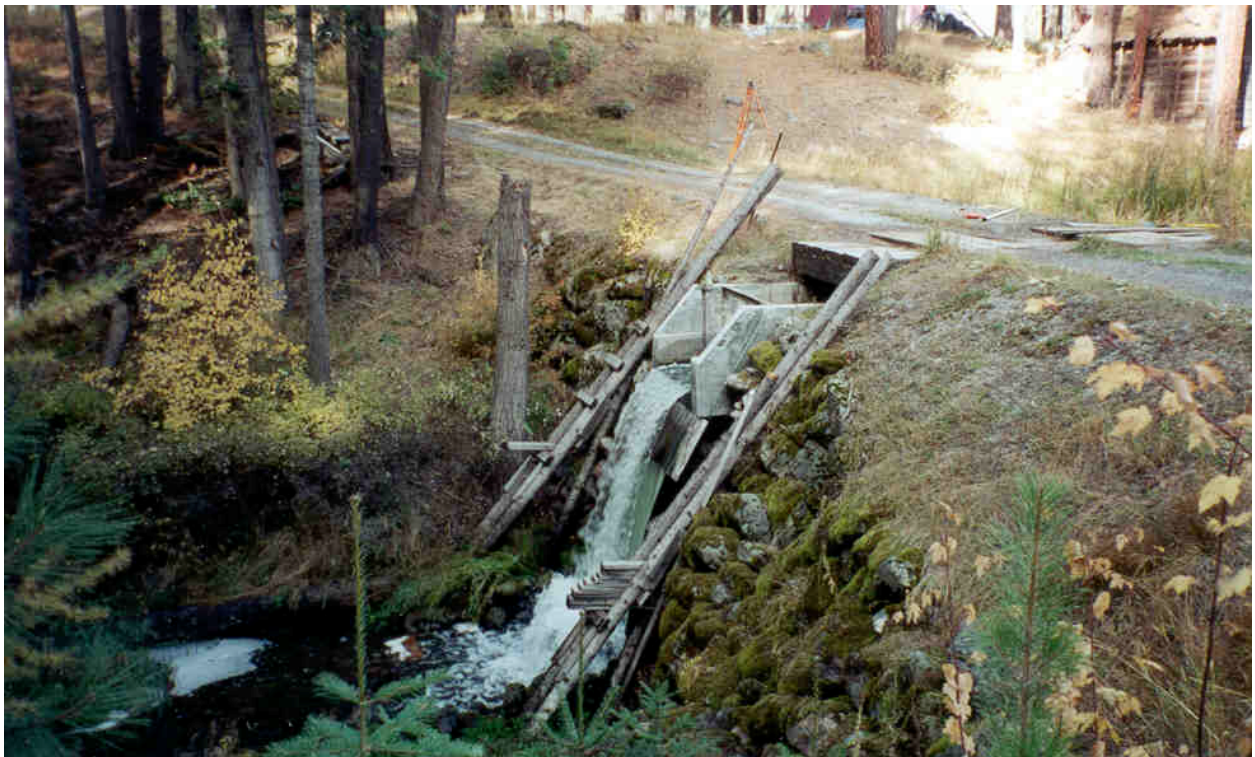
Photo 4: Downstream Face Looking North
